# Characterisation of lead pipes used in the water industry: extrusion processing, alloy microstructure and their role in service failures

N. Starling<sup>\*1,2</sup>, H. M. S. Belmonte<sup>1</sup>, M. A. Shepherd<sup>1</sup>, M. J. Mulheron<sup>2</sup> and P. A. Smith<sup>2</sup>

**Keywords:** Lead, Condition assessment, Microstructure, Mechanical properties

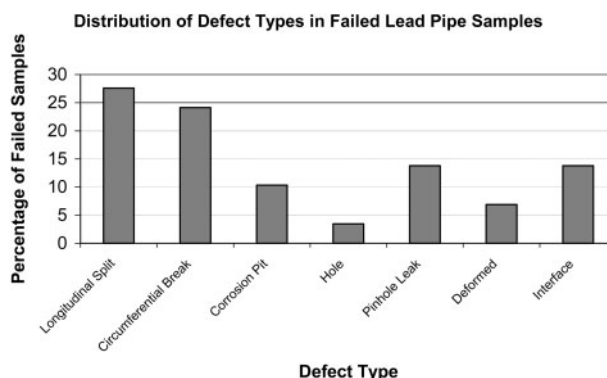
Of those pipes obtained which had a failure (as apparent from visual inspection or from pressurisation of the extracted pipe section), different failure types can be classified. The WRc plc employs a classification system that enables failed pipes to be assigned to one of seven categories.<sup>3</sup> This classification system has been applied to the failed lead pipes in the present work in Fig. 3. Of these failure modes, the longitudinal split and circumferential break are self-explanatory. Some differentiation needs to be made between a corrosion pit and a hole. A corrosion pit will be present on pipe that exhibits visible signs of corrosion whereas a hole may be present on an otherwise sound pipe and may possibly indicate mechanical damage. A pinhole leak is such that it may not be visible until a low pressure test is carried out. A ‘deformation’ failure is, as the name suggests, where the pipe has been crushed or deformed, either as a result of its installation or possibly owing to ground loading. An ‘interface’ failure is where a leak is apparent at the interface between the pipe and another asset such as polyethylene pipe or OSV. Any one pipe may contain a number of different failures. It can be seen from the graph that the most frequently occurring failures are longitudinal and transverse (or circumferential) fractures.

3 Distribution of defect types in failed lead pipe samples

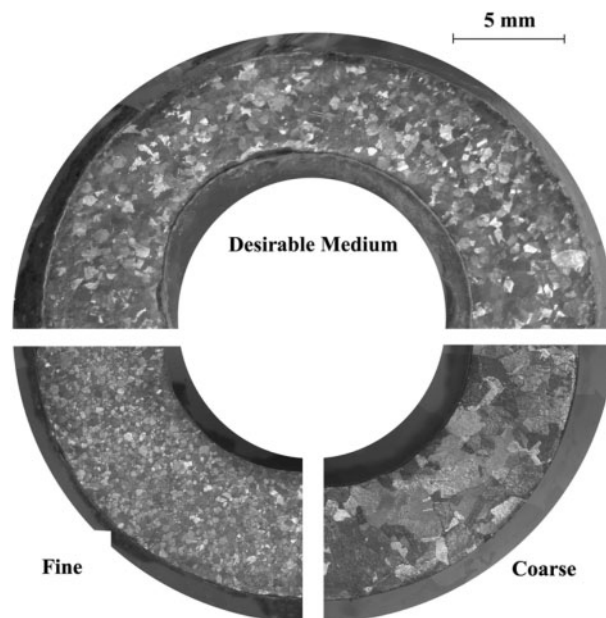
4 Variation in grain size observed in lead pipe samples

The grain size was found to vary significantly. Figure 4 shows a number of partial cross-sections from pipes with a range of microstructures; one section exhibits the

'desirable medium grain size' ( $\sim 0.5$  mm) specified by the British Standard, while the others exhibit the extremes of coarse and fine grain sizes that were seen.

examination, lead pipes should exhibit a uniform microstructure with a 'desirable medium grain structure'. This equates to a grain size of  $\sim 0.5$  mm. Many of the samples examined in the present work do not show such a mean grain size. Furthermore, many of the pipe sections exhibited what is cited commonly as a 'zoned' grain structure. This is characterised by circumferentially opposed areas of fine and coarse grains. This zoned structure is a product of bending and coiling of the lead pipes upon leaving the extrusion press, which subsequently results in recrystallisation and grain growth within the pipe.<sup>12,13</sup> A typical zoned structure is shown in Fig. 5. The regions of coarse grains are clearly visible in the upper and lower quadrants of the section; with a visible transition from 'fine' to 'coarse' grains.

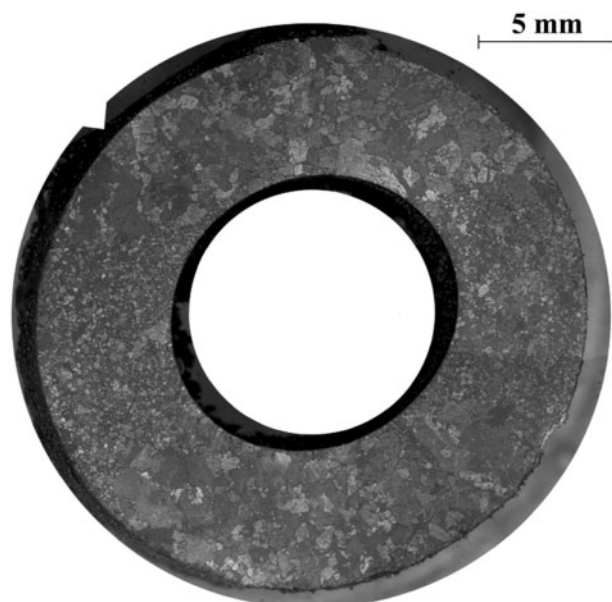
5 Lead pipe sample exhibiting 'zoned' grain structure

Butler<sup>14</sup> found that in creep tests under internal pressure, those pipes that exhibit a zoned structure showed non-uniform expansion owing to the differing rates of creep between fine and coarse grain lead. He also showed that in fatigue tests there was a tendency for cracks to propagate at the boundary between the coarse grained and fine grained regions. This can be attributed to the presence of stress concentrations at the transition zone. Butler noted that the fatigue strength of a lead pipe with a zoned structure is less than that of a pipe with uniform structure whether it is fine or coarse. In practice quenching the pipe as it leaves the extrusion press can prevent zoning.

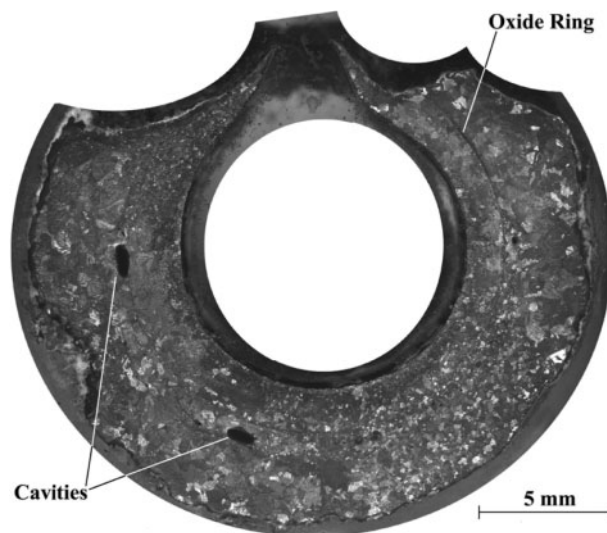
6 Failed lead pipe showing oxide ring and associated cavities

Many pipes exhibit defects as a result of the extrusion process. One such defect is when the pipe has a 'scarf' joint running longitudinally. This appears as a ring of oxidised material, when the pipe is cut transversely. This oxide layer is introduced during the extrusion process as the charge is replaced. As the slug from one operation is left in the container, a layer of oxide is formed on the surface. A new charge is then placed in the container on top of the oxide layer and the extrusion process continues. This layer of oxide is then dragged through the length of the pipe as the extrusion process takes place. Figure 6 shows a transverse section from a failed

lead service pipe and the oxide ring is apparent. There are weak metal/oxide interfaces associated with the oxide layer and associated with the interface is the occurrence of cavities, which result in a local reduction in cross-section. The lead pipe on either side of the oxide rings may show different characteristic grain sizes with associated problems as highlighted earlier.

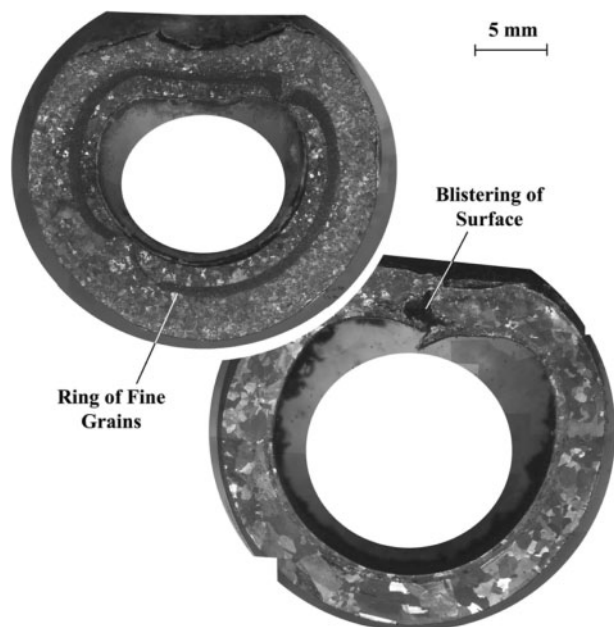
**7 Defects resulting from change in charge in extrusion press**

Other problems can also arise from the process of replacing the charge in the press during the extrusion process. Owing to a number of factors such as friction along the walls of the container and the internal surfaces of the die block, along with higher temperatures at the centre of the charge, movement towards the die block is fastest in the middle. This results in the lead from the new charge protruding in to the lead from the old charge inside the forming chamber. This phenomenon exhibits itself in the microstructure in the form of 'metal tongues'. These metal tongues ultimately meet, to form weld seams at two circumferentially opposed areas of the pipe. This is illustrated in Fig. 7, by the ring of fine grains. In very extreme cases, for example if the ring is very close to the surface of the pipe, this can cause blistering of the surface owing to an insufficient weld between the charges.

It should be noted that oxide layers are not introduced to the same extent when a method of continuous extrusion is utilised, as there is no need to stop the press to replace the charge. Hence the defects described above are not generally seen in continuously extruded pipes.

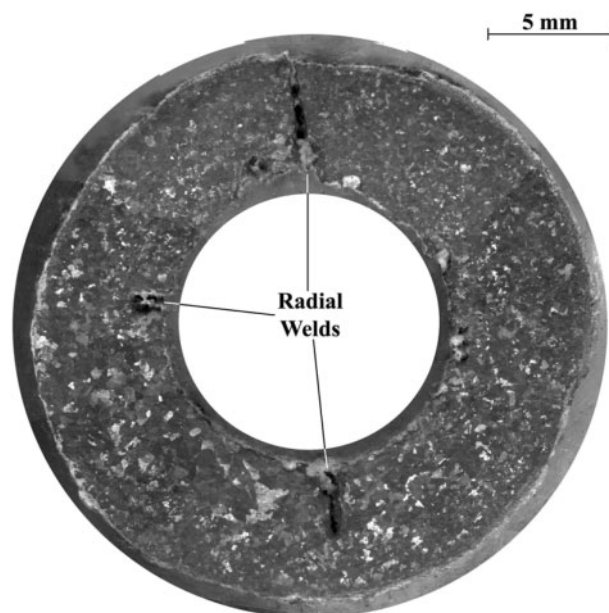
Another defect that arises as a direct result of the extrusion process is particular to those presses which utilise a bridge die. In such a set-up, the mandrel bar is connected to the die by spider arms, which can range in number from one to four. This can cause problems because the radial welds, which are formed as the lead reunites after the extruded section has passed the spider arms, are often of an imperfect nature. This is exacerbated if oxide and dross contained in the charge are drawn out behind the arms on extrusion, as this will

**8 Lead pipe sample with longitudinal splits resulting from improper welds at spider arms**

certainly inhibit the formation of a strong weld between the two joining parts. In extreme cases the use of a bridge die may lead to the formation of longitudinal splits from the sites of the joins. A transverse section illustrating poorly formed welds is shown in Fig. 8.

Many of the defects seen in the extrusion process are often ascribed to the extrusion temperature being too low. This prevents the oxide and dross in the melt from rising to the surface of the charge and so promotes the formation of internal defects. It has been noted already that many of the microstructural defects associated with the extrusion process can be avoided by using a method of continuous extrusion. It was also observed by McKeown and Hopkins<sup>14</sup> that the grains in lead pipes extruded on the continuous press were uniform in size and structure, while those produced on the hydraulic press produced a grain structure that was more irregular in size and structure. Therefore it would seem that those pipes produced on a continuous extrusion press would tend to exhibit a more desirable grain structure as well as containing fewer defects.
