The static and fatigue responses of aged metal laminate doublers joints under tension loading

Sugiman Sugiman^a, Andrew David Crocombe^{b,*}

Abstract

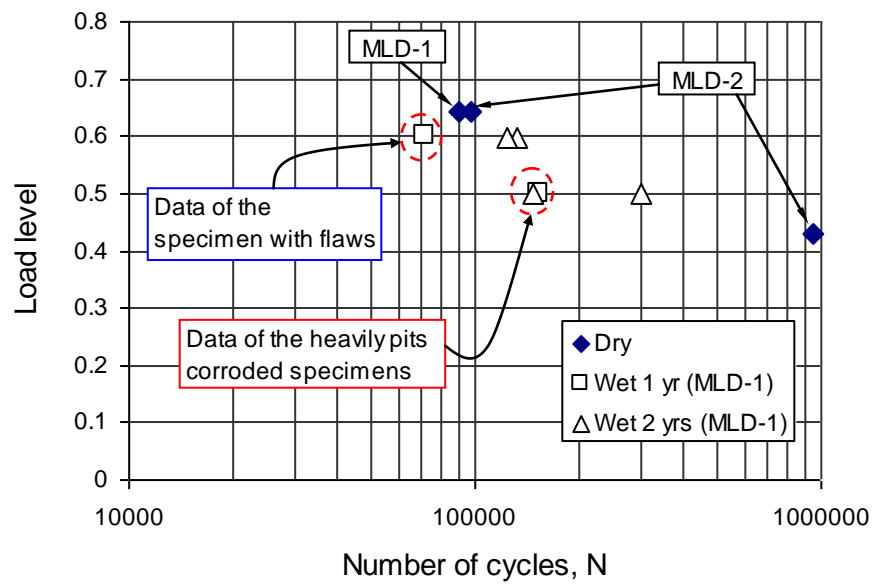
Figure 3. Fatigue load-life time curves of MLD specimens.

Figure 3. Fatigue load-life time curves of MLD specimens.

either the manufacturing flaw or heavily corroded pits just under the stringer edge (shown by the circles in Figure 3). The testing was carried out at the higher load level (60%). In Figure 5(a), for the specimen aged wet for 2 yrs, initial failure occurred in the stringer bondline at around 3,000 cycles. The image **a** shows the failure in the fillet and the adhesive layer at both sides at 15,000 cycles, but this did not grow further toward the centre of the joint. The first aluminium failure occurred at 86,000 cycles close to the stringer edge (image **b**), unlike the dry specimens where aluminium failure first occurred around the external butt. At this site, corrosion pits occurred that created a high stress concentration. Furthermore, this region experienced secondary bending due to the tension loading of the MLD increasing the tensile stress. After this failure, the crack propagated through the adhesive layer. At 112,000 cycles, the second aluminium layer failed (image **c**) and then crack propagated along the laminate adhesive layer (delamination). The aluminium layer at **d** failed at 124,000 cycles due to pitting corrosion that created a stress concentration superimposed with the secondary bending effect. This was soon followed by the final fracture of the specimen.

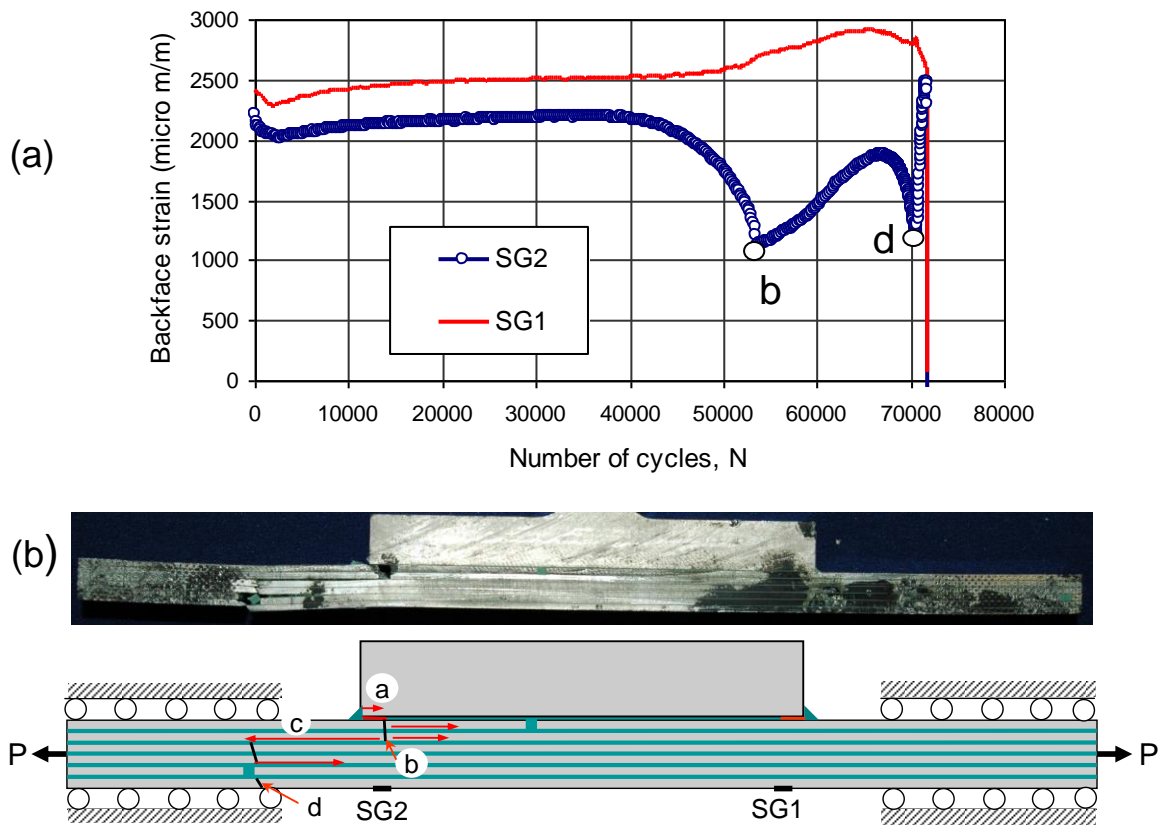
Figure 6. Failure process of the MLD-1 (aged wet 1 yr) under tension fatigue at 60% load level, (a) BFS history, (b) The photograph of failed specimen and its schematic damage process.

In monitoring the failure process of the MLDs under tension fatigue, the backface strain (BFS) method was utilised as it had previously successfully indicated damage in the adhesive in a single lap joint under shear fatigue in a SLJ [40,41,42] and in a MLD under bending fatigue [32]. In the MLD under tension fatigue reported here, the BFS history indicates the damage in the stringer bondline, the butt and the aluminium layers. Figure 6(a) and Figure 6(b) respectively show the BFS history during fatigue loading at 60% load level of the MLD-1 after 1 year ageing and the schematic of damage process. It can be seen that the damage of the stringer bondline occurred at around 3000 cycles (point a) indicated by increasing BFS in both gauges. The damage progressing at this site continued until 40,000 cycles and then stopped growing when the damage of aluminium just inside the stringer initiated and propagated. At this site there was a semi circular manufacturing flaw that might produce the early failure. This was indicated by much lowering decreasing BFS at SG2 after these cycles due to the bending of the

Figure 6. Failure process of the MLD-1 (aged wet 1 yr) under tension fatigue at 60% load level, (a) BFS history, (b) The photograph of failed specimen and its schematic damage process.

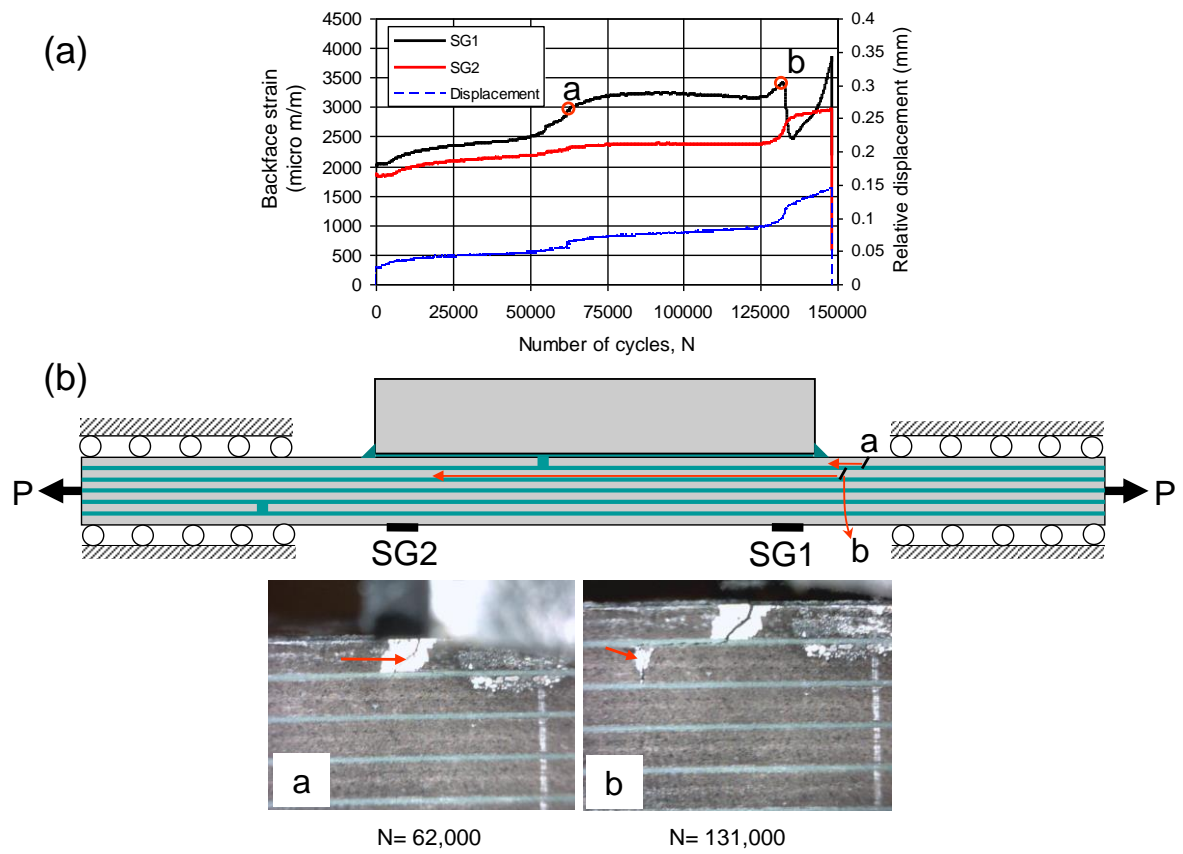
Figure 7. Failure process of the MLD-1 (aged wet 2 yrs) in tension fatigue at 50% load level, (a) BFS history, (b) Schematic of damage process.

Figure 7. Failure process of the MLD-1 (aged wet 2 yrs) in tension fatigue at 50% load level, (a) BFS history, (b) Schematic of damage process.

At a lower load level (50%) the BFS history and the failure process of the MLD-1 at 2 years exposure is shown in Figure 7. In Figure 7(a), at the early stage of fatigue loading, the backface strain at both strain gauges increased gradually due to both the damage initiation of the stringer bondline and the upper aluminium layer close to the stringer edge. The careful examination showed that there was a corrosion pit at the upper aluminium surface. At around 50,000 cycles the strain of SG1 started to increase more rapidly until point *a* (62,000 cycles), meanwhile the strain of SG2 grew more stably. This increase of strain is related to the initiation and propagation of damage in the aluminium (image *a*) as shown in Figure 7(b). After the failure of the aluminium at that site, the backface strain became more stable. This is related to the propagation of crack in the laminate adhesive layer toward the stringer edge. As the crack approached the edge of stringer, more bending in the laminate occurred which affected the backface strain at SG1, causing it to decrease because of the bending. The backface strain increased again abruptly to point *b* when the second aluminium layer failed, close to the first failure, at around 131,000 cycles. As the load carrying cross section area decreased after the failure of the two aluminium layers, the stress in the rest of aluminium increased leading to increasing backface strain at SG2. At the same time, the backface strain of SG1 decreased abruptly and increased again rapidly until complete failure. The decrease and increase of backface strain of SG1 after point *b* is due to high bending after failure at that location, which causes more compressive stress and then recovers to become more tensile when the damage grows along the laminate adhesive layer.

In Figure 7(a), the relative displacement during fatigue loading is also shown for comparison with the BFS. The relative displacement was calculated by subtracting the displacement at P_{\max} with the displacement at P_{\min} . It is seen that the history of displacement has the similar pattern with the BFS at SG2, where there was no local damage as occurred at the SG1 side. Hence the measured strain at this side was mostly the elongation of the specimen. This fact indicates that although the displacement history is able to monitor the damage in a specimen it is not sufficiently sensitive to indicate a localised damage in the specimen. Meanwhile, the BFS method is a very useful tool to monitor the localised as well as the global damage.
