# Damage Identification of Slab-girder Structures: Experimental Studies

*Keywords: Slab-girder structure; Shear connector; Static test; Vibration test; Mode shape.*

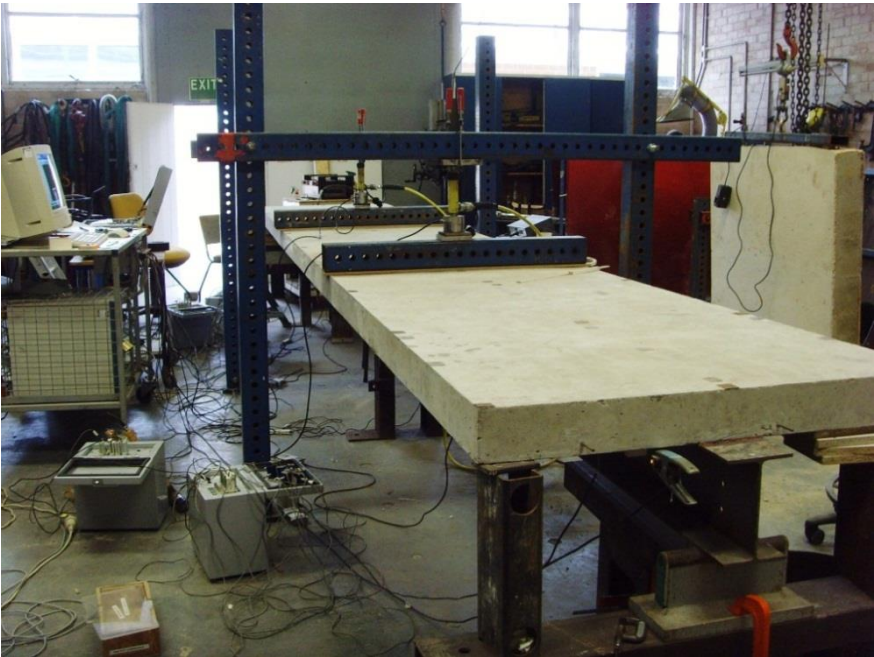
a) Slab-girder system

b) Headed stud

c) Removable shear connector

Figure 1 Slab-girder system

A composite slab-girder structure was designed in accordance with AS2327.1 (2003), as shown in Fig. 1 (a). It comprised of a 200UB22.3 steel member and a Grade 40 concrete slab with a depth of 100 mm and a width of 1000 mm. The longitudinal and transverse slab reinforcement was provided by a 100 mm × 100 mm × 5 mm thick mesh sheeting. The slab-girder system was simply supported, with a span of 6 m. The span was selected to fulfil both technical and practical requirements, specifically large enough to perform tests under several damage scenarios while not exceeding the allowable laboratory space. The shear connection between the steel and concrete members was designed and constructed using 20 mm 8.8/S bolts with 300 mm spacing. Two types of connectors were used: the headed stud and the removable bolt (Fig. 1 (b) and (c)). The headed studs were installed by welding 20 mm high strength structural bolts in the middle section of the composite beam. The removable bolt was designed to simulate both undamaged and damage states, located both 1/4 parts near the ends as shown in Fig. 1(d). The holes were punched in the steel beam, and 80 mm long nuts were welded to cover them. After concrete was poured, the nuts were permanently fixed and provided

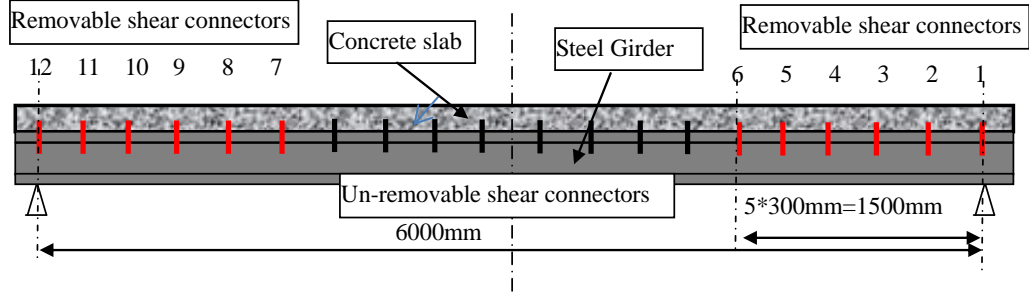
d) Removable shear connector locations

In order to examine the suitability and efficiency of various vibration-based damage identification methods for structural condition assessment, a two-stage test was conducted. In the first stage, damage was introduced into the system by removing a certain number of shear connectors from different locations. In the second stage, all the removable bolts were removed. Then, two static loads were applied at the 1/3 points of the structure. These loads were increased step by step until inducing crack damage on the concrete slab. Totally, six damage scenarios were explored in this study ranging from an undamaged case (DS0) to final damaged case (DS5) when structures were loaded until concrete cracked. The damage cases are summarised in Table 1, where S1-S12 indicate No. 1 to No.12 shear connectors shown in Fig. 1(d).

In the second time, the structure was loaded until concrete cracked. The static loading and deflection histories are shown in Fig. 8. Based on theoretical results, it is found that if there is no interaction between concrete and steel, concrete slab will crack in its tension zone when load  $P$  is larger than 4.17 kN. While if full interaction is considered, the failure loading will be 45.71 kN, ten times larger than the former result. As can be seen in Fig. 8(a), the failure load is 42 kN and 40 kN for south and north loadings, respectively. The values are close to the theoretical results when the girder and slab is fully connected, demonstrating that the load-carrying capacity of the composite slab-girder system will drop slightly even after a large numbers of shear connectors are damaged (provided that a number of connectors are still working). Specifically, all the removable shear connectors (Figure 1(d)) are removed, representing that 60% of shear connectors are damaged.

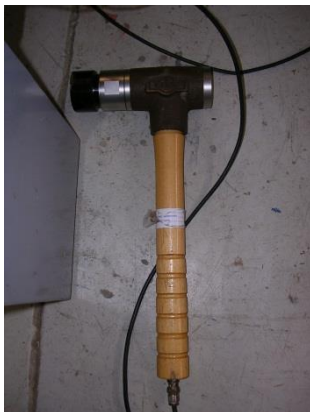
b) Impact hammer

The vibration test system, as shown in Fig. 2, mainly consists of three parts: 1) an impact hammer to provide impulse load; 2) the accelerometers to measure acceleration on the structure; 3) the data transmission devices to collect data from sensors and to transfer them to the computer. For each damage scenario, the vibration tests were conducted by exciting the beam with an instrumented impact hammer (Type 5802A from Dytran Instruments Inc.) and recording structural accelerations by nine accelerometers. The responses of the composite structure were obtained at 36 locations which were divided into four sets of data: Set 1 (locations 1-9), Set 2 (locations 10-18) and Set 3 (locations 19-27) on the slab and Set 4 (locations 28-36) on the steel beam, the sensors were distributed as shown in Fig. 3. Six impact tests were performed in each set for each damage case to get an averaged result.

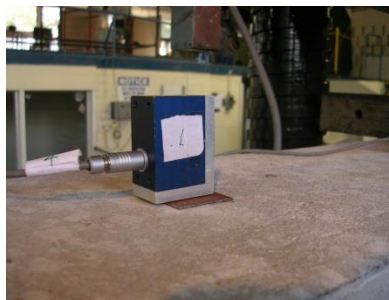
c) Accelerometer

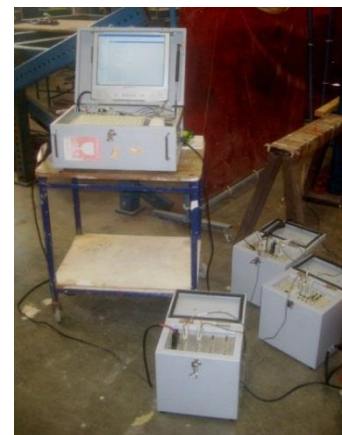
d) Unit boxes and computer

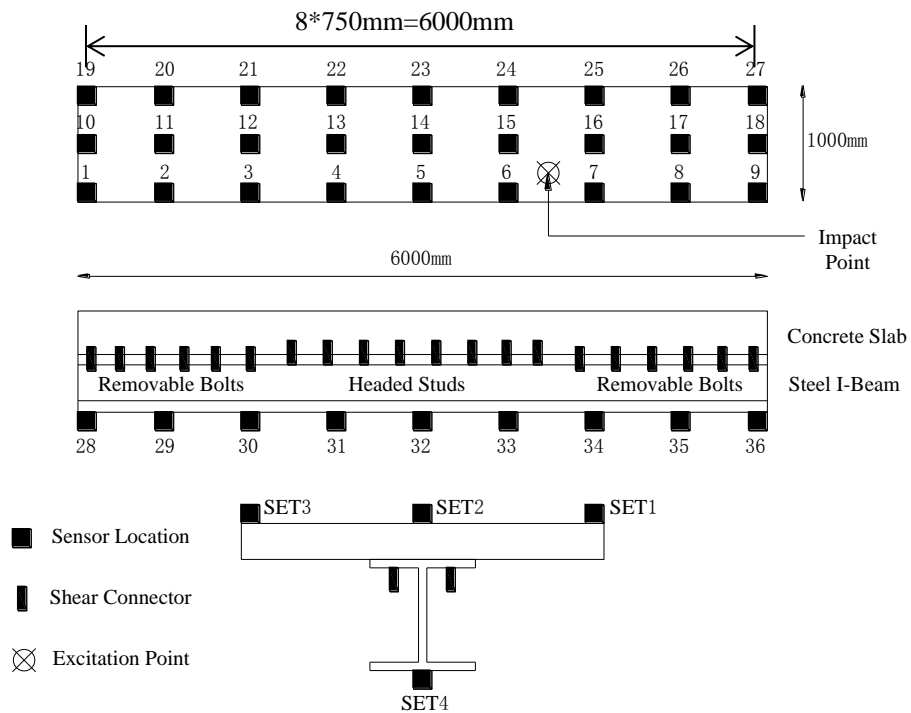
Figure 3 Sensor locations

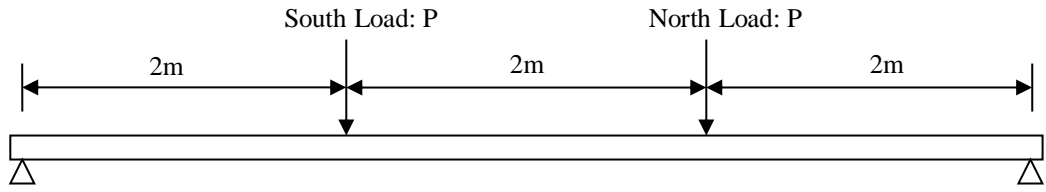
a) Locations of static loads

Figure 4 Static loading system

For static test, two sets of hydraulic loading equipment were used to apply static loads on the slab-girder system, as shown in Fig. 4. The locations are illustrated in

Fig 4(a). Loading history was recorded by using the load cell, symbolised by a red circle in Fig. 4 (c). The deflections at different locations of the structure were also recorded by using laser and spring displacement sensors for monitoring purposes, as shown in Fig. 5. In order to take unexpected vertical displacements at the support locations into consideration, three spring displacement sensors were placed vertically under the beam. Two of them were next to the supports and the other one was at the middle of the beam, as shown in Fig. 5(b). Further, six laser displacement sensors were placed horizontally to monitor the relative displacement between the concrete slab and steel girder. As can be seen in Fig. 5(c), a white wood plate was used together with the lasers. The plates were attached on the concrete slab while the laser sensors were fastened at the steel girder by using the clamps. Totally, six laser sensors and three spring sensors were used in this study. Their locations were shown in Fig. 5(a).

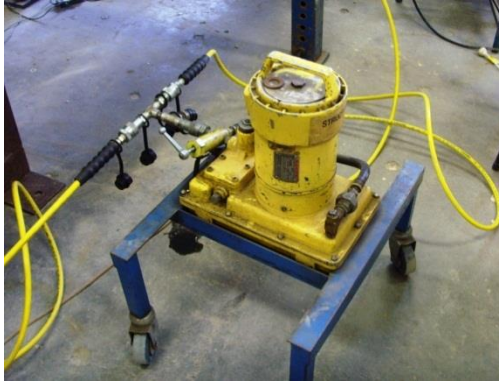
b) Hydraulic equipment

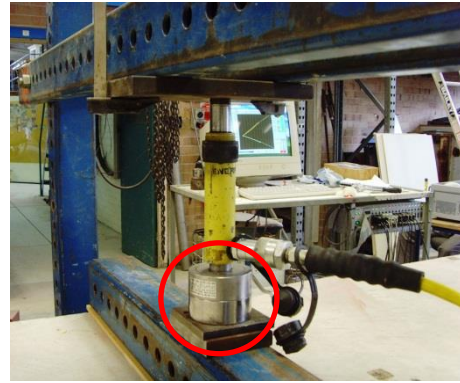
c) Load cell and hydraulic equipment

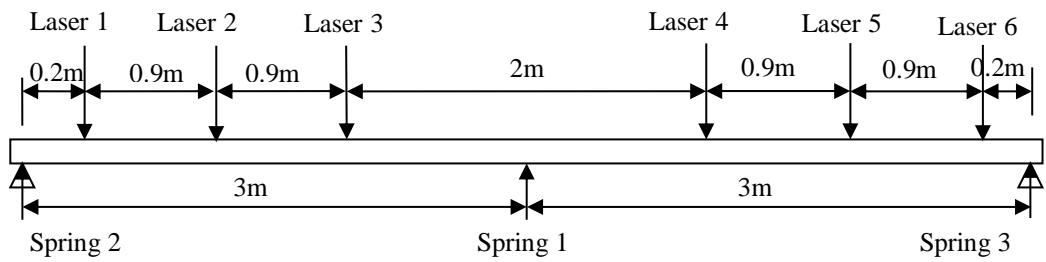
a) Locations of displacement sensors

Figure 5 Deflection monitoring system

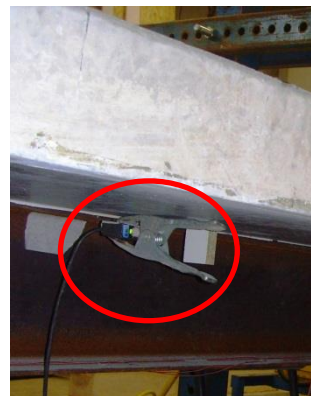
c) Laser displacement sensor

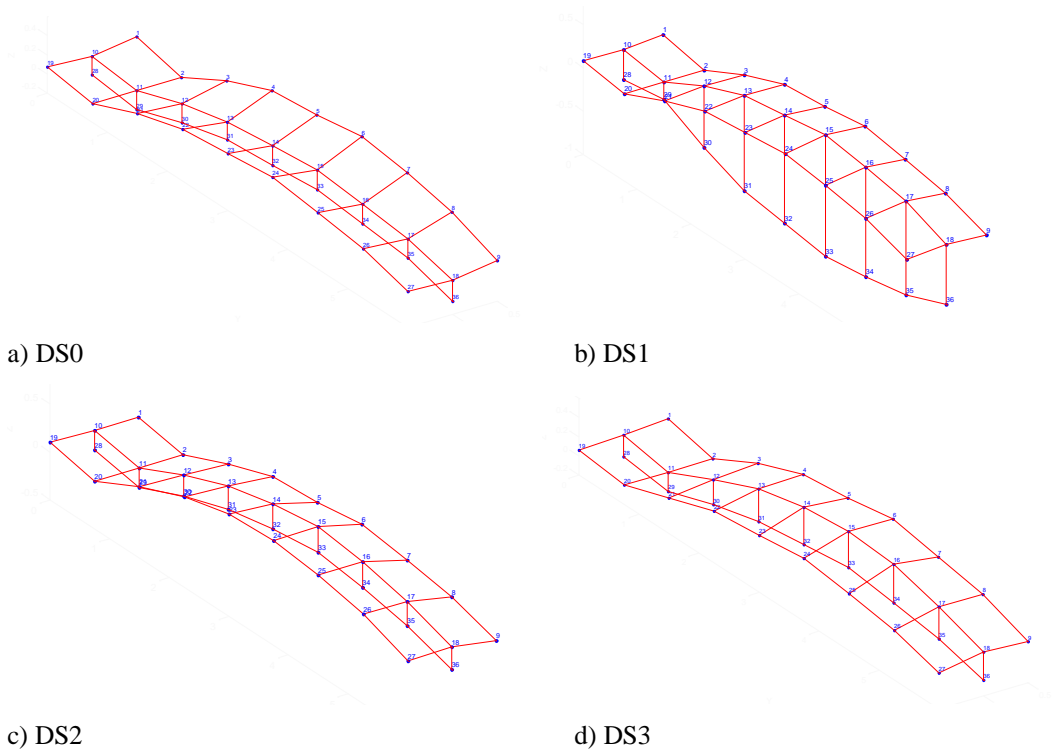
Figure 6 First mode of the slab-girder system to damage scenarios of DS0, DS1, DS2, and DS3

As can be seen, for the intact structure, totally 28 modes can be identified, including 8 bending modes, 8 torsional modes and 12 local modes. It should be noted that in the local modes, only part of the structure vibrates, i.e., left south part of the concrete slab. For shear connector removal damage cases, specifically DS1, DS2 and DS3, five/six local modes together with one torsional mode cannot be identified, specifically No. 11, 12, 21, 24 and 27. For those identified, the changes of natural frequencies are very small (-2.36% at most). In contrast, the mode shape changes are obvious. Some of the mode shapes for damaged cases show apparent discrepancy between steel girder and concrete slab. For example, Figs 6 and 7 show the first and second mode shapes for four damage scenarios, respectively. For both modes, the mode shapes for DS1 show that the vibration directions of slab and girder become opposite. The results may indicate that the method proposed by Xia et al. (2007) is suitable for shear connector damage identification in a slab-girder structure. However, the shapes of the first mode for DS2 and DS3 do not show any apparent discrepancy. The shapes of the second mode for DS2 and DS3 show that there is discrepancy between slab and girder, but this discrepancy is not as large as the results for DS1. The reason may be that the end bolts have the biggest influence on the vibration results. The changes of mode shapes are very complex, and therefore the appropriate application of this method needs further studies.

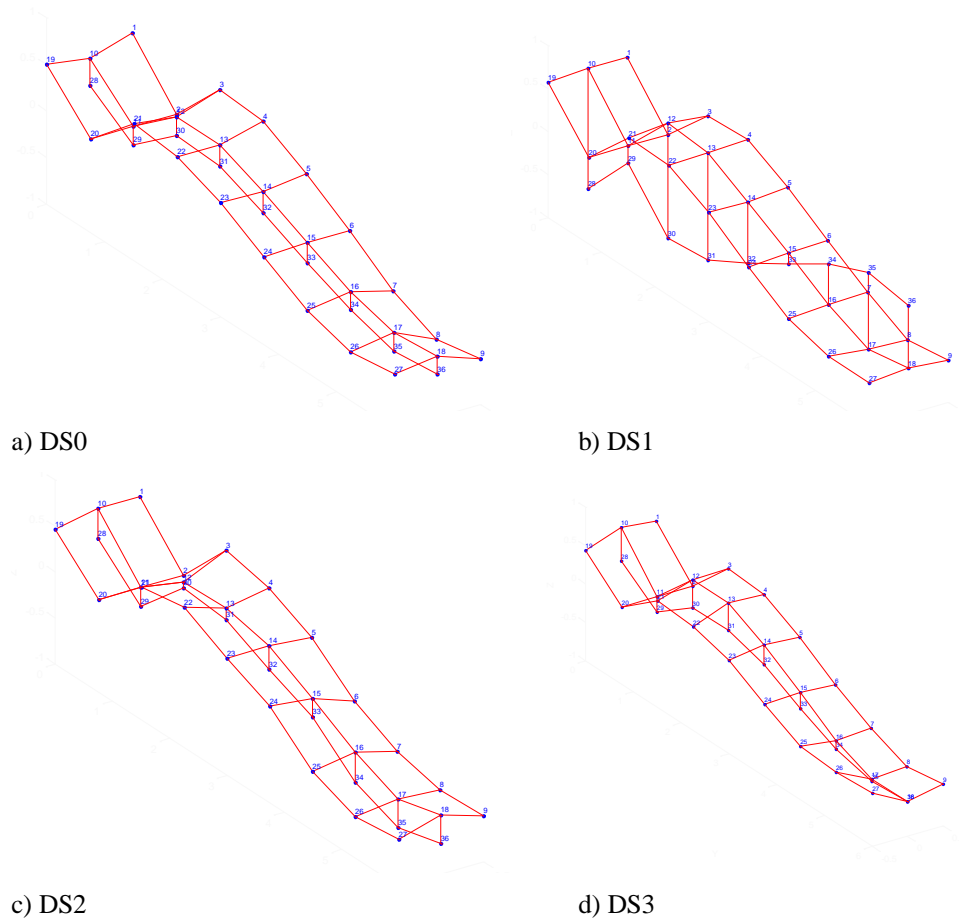
Figure 7 Second mode of the slab-girder system to damage scenarios of DS0, DS1, DS2, and DS3

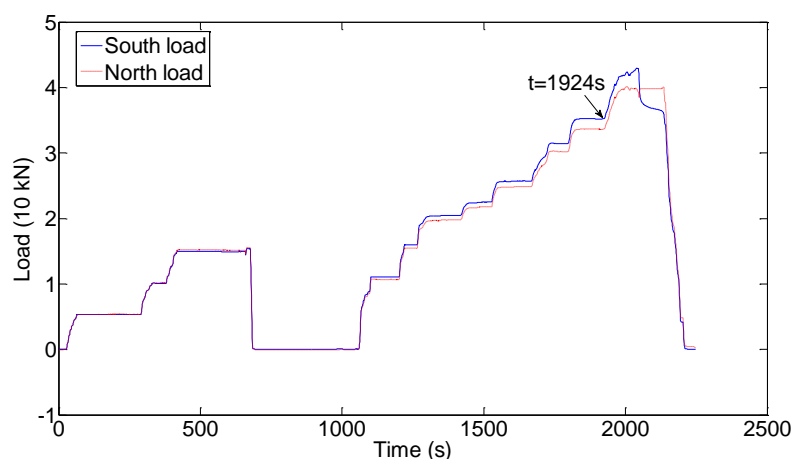
a) Load history

Figure 8 Static test results

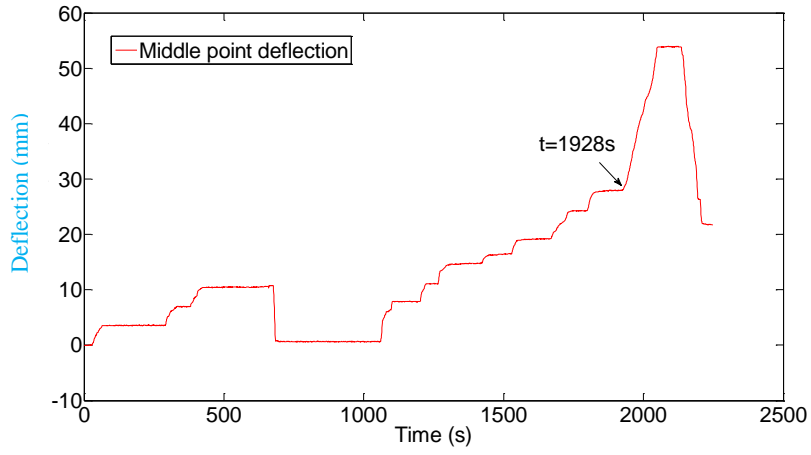
b) Middle point deflection history

By deducting the support deflections, the final displacement in the middle point is around 54 mm. The theoretical deflection results lie in the range between 16 mm and 116 mm with and without shear connectors, respectively. This result indicates that the stiffness of the composite slab-girder system may drop substantially after a number of shear connectors are damaged.

As can be seen in Fig. 8(b), the deflection at the middle point increased fast from 28 mm to 54mm in the time span of 1928s to 2052s. In this time range, the final

loading step was just performed; concrete started cracking; and the structure nearly reached its load-carrying capacity. There are mainly two cracks, which are located at 13 cm and 16 cm to the loading points respectively. The locations coincide with where the last row of the headed studs is located at. The largest crack width is 8mm. The cracked structure is shown in Fig. 9.

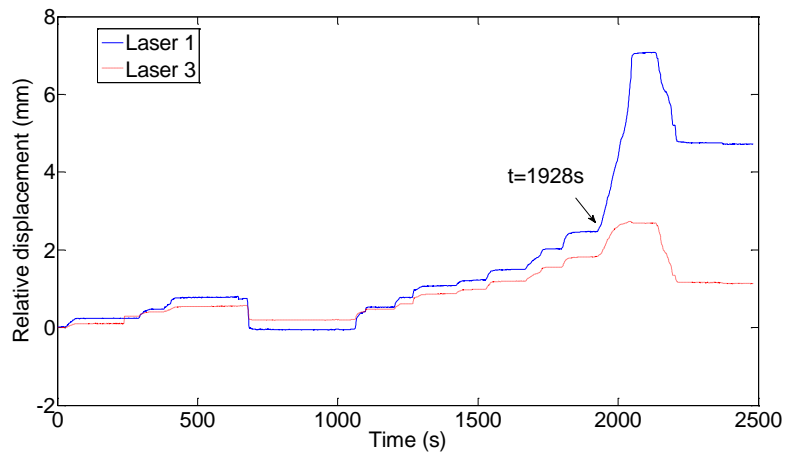
c) Relative displacements between slab and girder (from lasers 1 and 3)

The relative displacements between slab and girder at various locations were also recorded. For example, the results from Lasers 1 and 3 are shown in Fig. 8(c). Theoretically, the relative displacement should be very small when slab and girder are fully connected. When some of the shear connectors were removed, as can be seen, relative displacement between slab and girder at the beam end became very prominent. During the early stage of loading, the relative displacement increases steadily with the loading. From 1928s to 2052s, coinciding with the sharp increase in vertical displacement, the relative displacement increases dramatically from 2.5 mm to 7 mm. This sharp increase in the relative displacement can be used as an indicator of composite structure damage. Compared with the middle point displacement, the advantages of using the relative displacement include that it is very easy to be measured and no reference point is needed. So it may be a better indicator for monitoring purposes. Further experimental verification studies are needed.

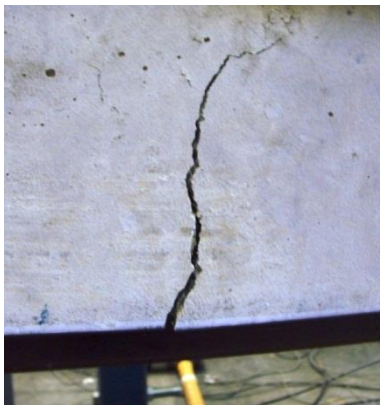
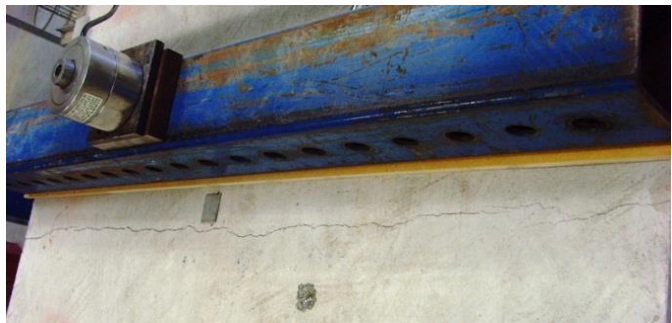
a) Side view

b) Top view

Figure 9 Damaged structure

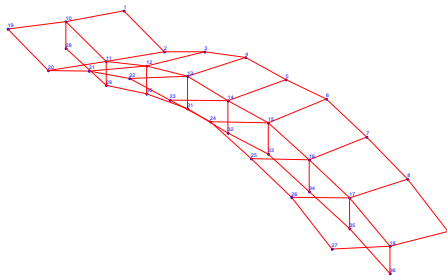
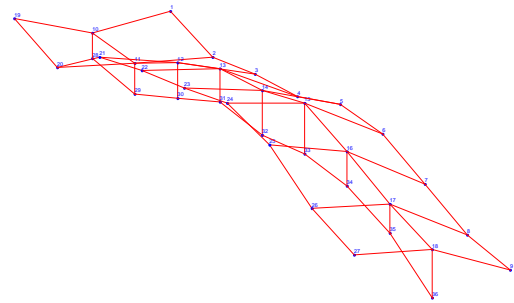
a) DS4

b) DS5

Figure 10 First mode of the slab-girder system to damage scenarios of DS4 and DS5

For the second stage, more modes cannot be identified and larger changes of the natural frequencies can be found. As can be seen in Table 3, for DS4, 18 modes are identified, including 5 bending modes, 7 torsional modes and 6 local modes. The change of the first bending mode is -3.01%, implying that the structural stiffness becomes lower if there is no adequate shear connector between steel girder and concrete slab. For DS5, only 12 modes are identified, including 3 bending modes, 4 torsional modes and 5 local modes. The change of the first bending mode is -20.68%, meaning that the structural stiffness decreases significantly when concrete slab cracks. In fact, under this condition, the structure will not be suitable for carrying loads. The first and second mode shapes for DS4 and DS5 are shown in Figs 10 and 11, respectively. As can be seen, although the first mode becomes irregular, the second mode shows more discrepancy. In fact, under scenarios with big damages (DS4 and DS5), natural frequencies are more suitable for damage identification.

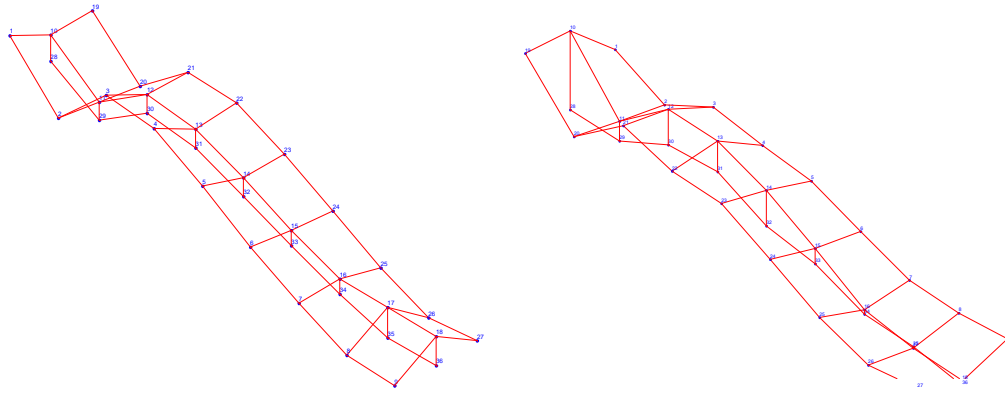
a) DS4

b) DS5

Figure 11 Second mode of the slab-girder system to damage scenarios of DS4 and DS5
